**Review and Report on Post Tropical Storm Dorian and Restoration**

**Post Tropical Storm Dorian  
Post-Mortem Report**

**November 8, 2019**

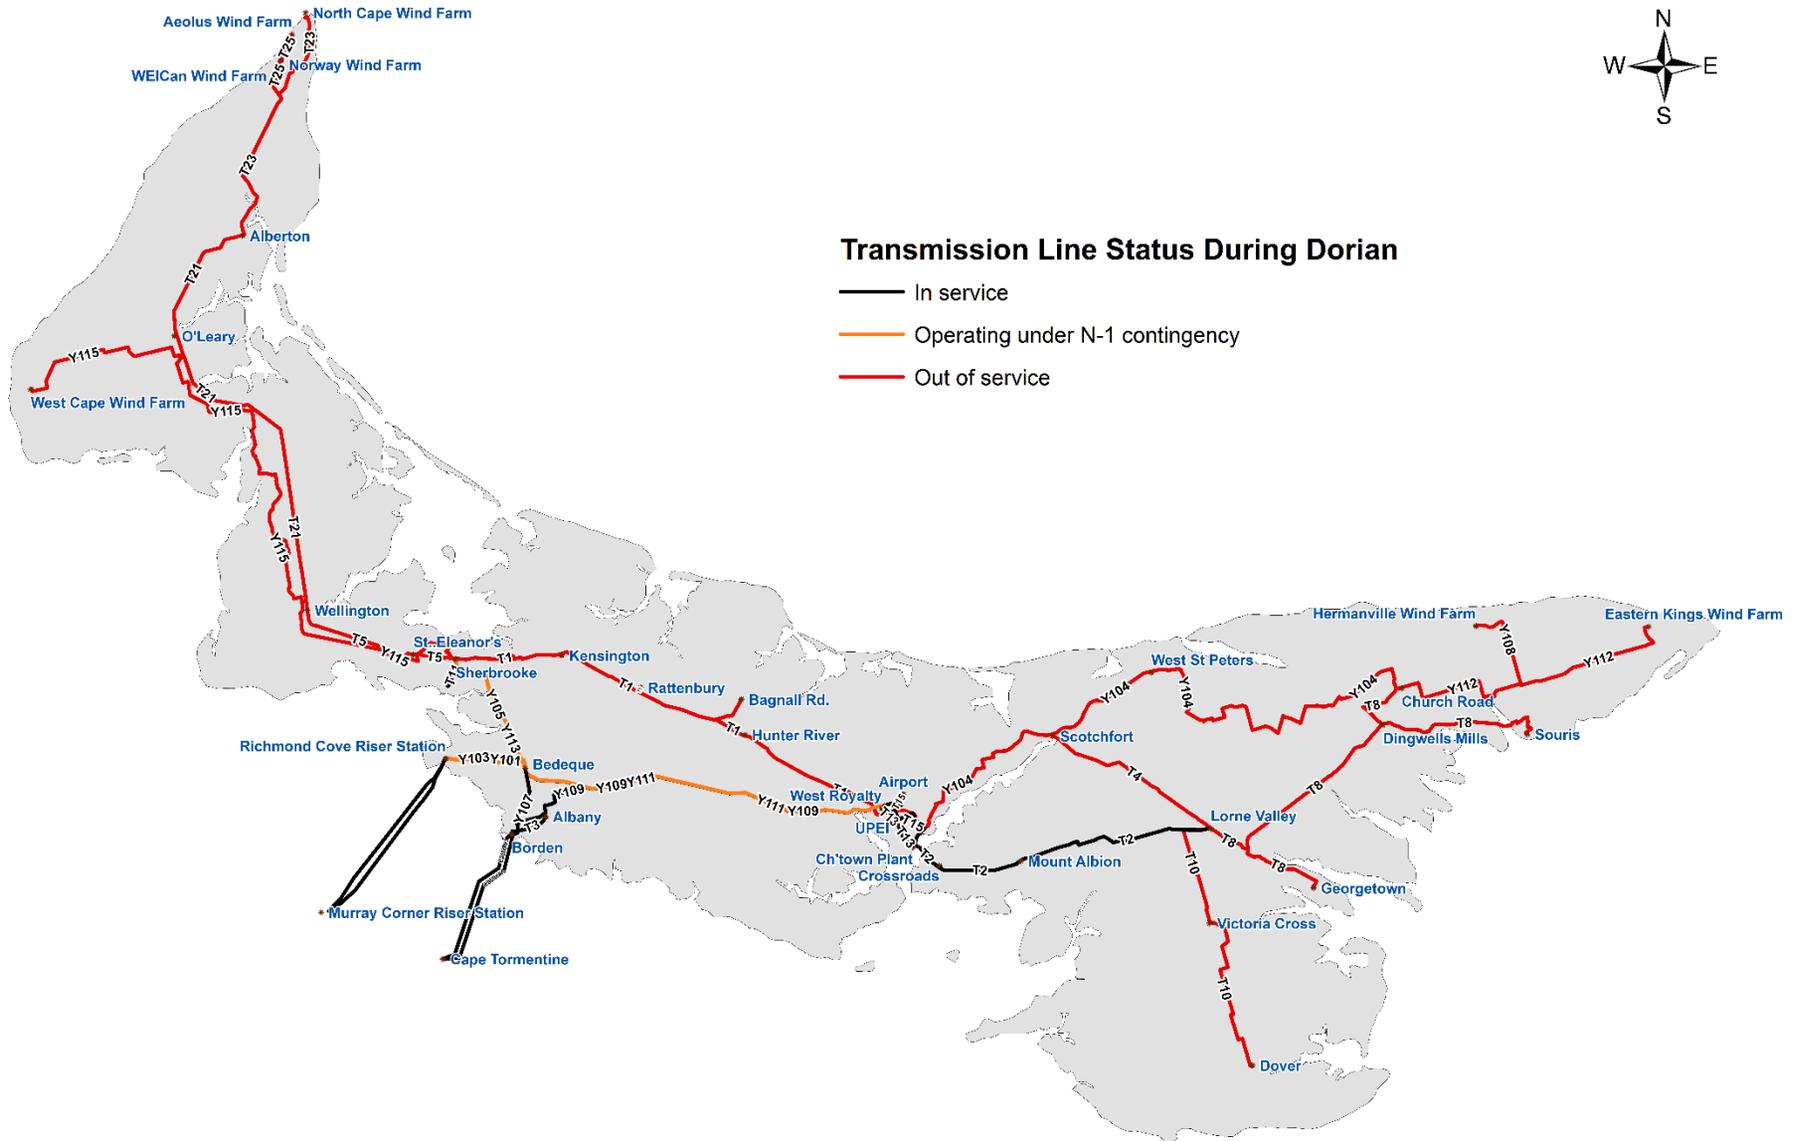
Figure 2: Transmission Line Status During Dorian

Restoration of the transmission system was a priority and completed within the first three days. The helicopter inspection of the transmission lines expedited the restoration. Transmission lines Y-103, Y-111 and Y-113 which operate with an N-1 contingency were also affected but this did not result in customer outages due to redundancies in the backbone transmission system. As shown in Figure 2 on page 5, North Cape, Norway, Aeolus, Eastern Kings and Hermanville wind farms were out of service for approximately three days as a result of the loss of transmission capabilities due to tree contacts. The West Cape wind farm was out of service for six days as a result of the number of fallen trees on the transmission line and on access routes.
