**Review and Report on Post Tropical Storm Dorian and Restoration**

**Post Tropical Storm Dorian  
Post-Mortem Report**

**November 8, 2019**

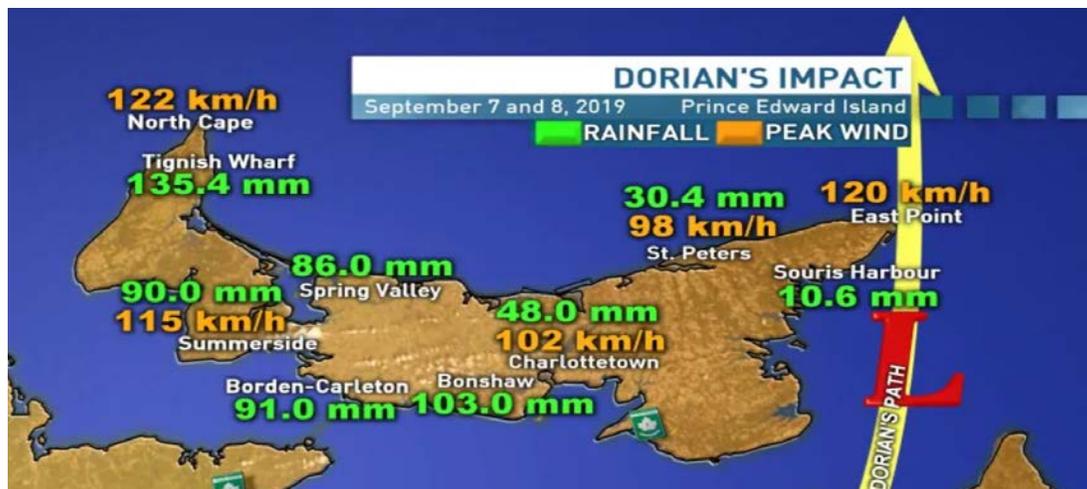
Figure 1: Peak and Cumulative Impacts of Post Tropical Storm Dorian

Post Tropical Storm Dorian was not a hurricane when it passed through PEI but it was more damaging than 2003's Hurricane Juan. In Dorian's case, the storm had been downgraded to a post tropical storm by the time it reached the Island but the storm picked up energy as it combined with another weather system moving in from the west. The result was destructive hurricane strength winds combined with heavy rainfall. All areas of the Island experienced winds exceeding 100 km/h and the western end of the Island received a significant amount of rainfall. Figure 1 is a map originally broadcast by CBC which shows the peak storm conditions experienced during the storm and cumulative precipitation across the Island.

The heavy rains created wet conditions softening the ground. The combination of high winds and soft ground caused trees to move and/or uproot creating numerous contacts with energized lines. A significant number of trees fell to the ground, breaking conductor and poles and causing transformers to fall to the ground. By daylight on the morning of Sunday, September 8<sup>th</sup>, the full impact of this storm was evident with hundreds of fallen trees on the ground and widespread power outages throughout the Province.

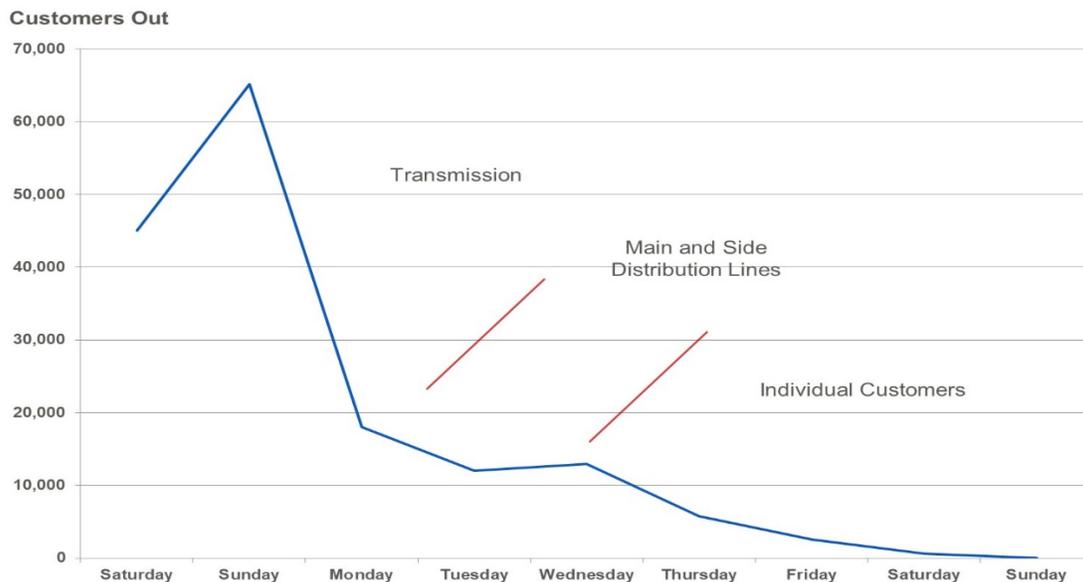
**Figure 3: Customer Outage Timeline for Post Tropical Storm Dorian**

The Company responded to distribution system outages immediately, but the majority of distribution system work was completed after the transmission system was restored. The restoration approach involved repairing the main feeders from substations followed by secondary feeders and individual outages. Power restoration to nonessential services and vacant residences were the last to be completed.

Significant damage to customer-owned service components delayed power restoration to some customers. Electricians were repairing numerous services from the storm and most components and hardware for repairs were in short supply on the Island.

Figure 3 below illustrates the customer outage timeline for Post Tropical Storm Dorian.

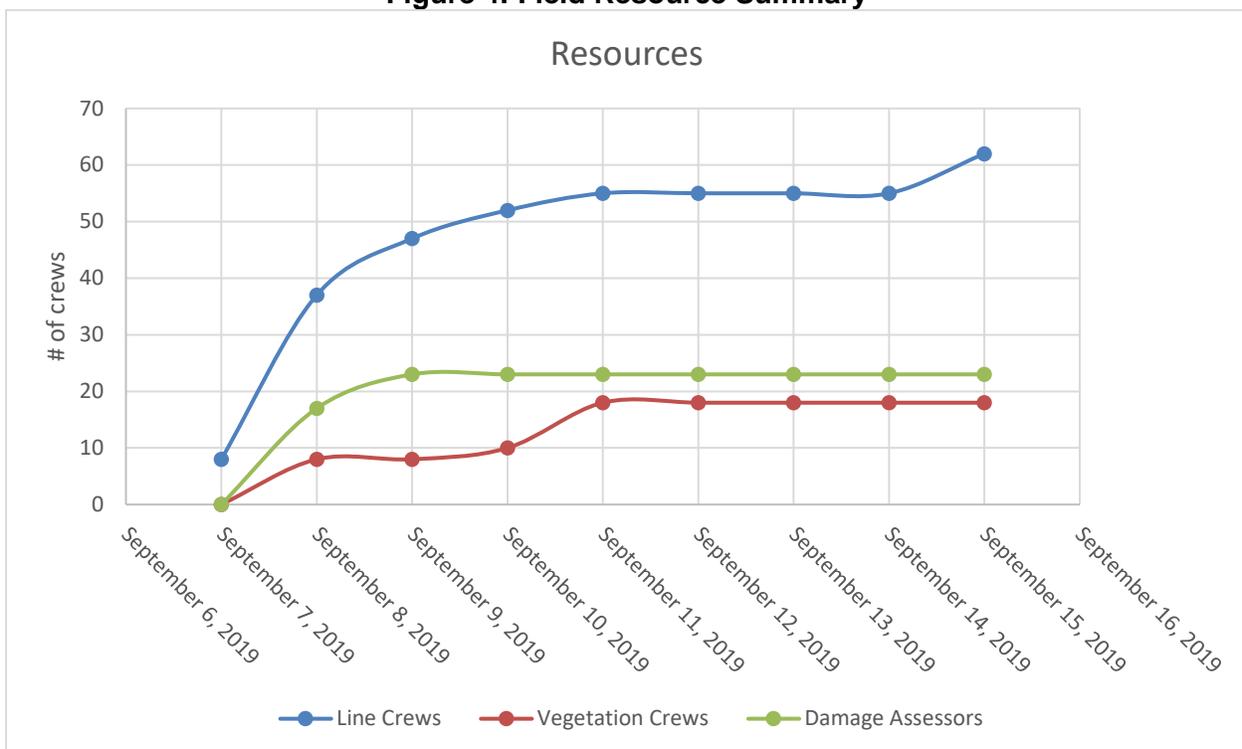
**Figure 4: Field Resource Summary**

safety orientation and dispatched to the field. A breakdown of the total number of crews working each day is provided in Figure 4 below. During the storm on September 7<sup>th</sup>, a decision was made to only have a minimum amount of line crews available to respond to emergency outages for safety reasons. However, during the restoration following the storm, up to 80 line and vegetation management crews and 22 damage assessors were dispatched across the Island. Additional mutual aid was provided by Saint John Energy and City of Summerside Electric Utility during the last two days of restoration.
